Doc #: Limited Investor Survey  
Date: 2/1/2013  
Address: 30199 Monte Vista Way, Thousand Palms, Ca.

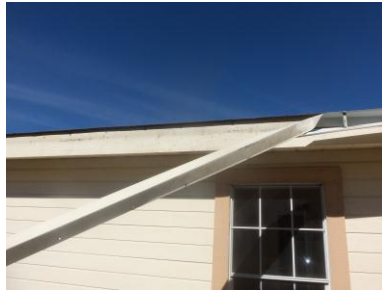
| Step # | Component | Comments |
|---|---|---|
| 1107 | Gutters/Downspouts | <b>Review.</b> Disconnected and damaged at left side. |

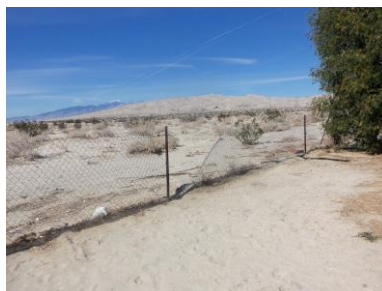
| 1108 | Fences/Gates | Weak chain link at several locations. |

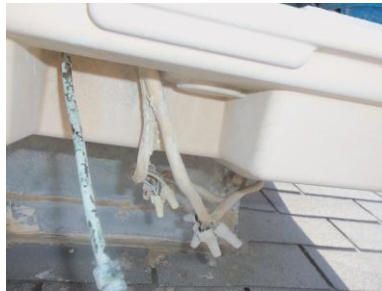
1. Open splices and missing service disconnect at roof mounted evaporative cooler were observed. This is a "Safety Concern". Whenever an electric wire is cut and reconnected, the "splice" should be encased in a covered "junction box" to prevent shocks and separation of the splice.

- Evaporative cooler requires a service disconnect.

LICENSED ELECTRICIAN; All electrical concerns should be reviewed/repared by a licensed electrician to ensure that items were properly installed, repaired or upgraded. Receipts of repairs should be obtained and kept with other important documents for future reference.

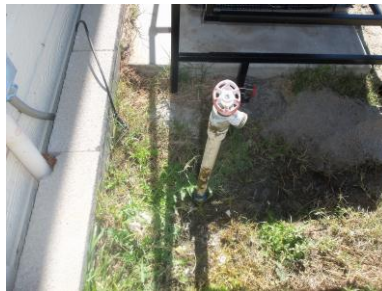
**1.** Non potable plastic piping at right rear corner should be removed or isolated from potable water supply.

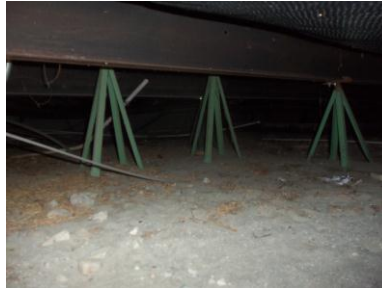
**1.** Standard jacks with non-bearing block walls at perimeters.

**2.** Installing a hatch cover is advised.

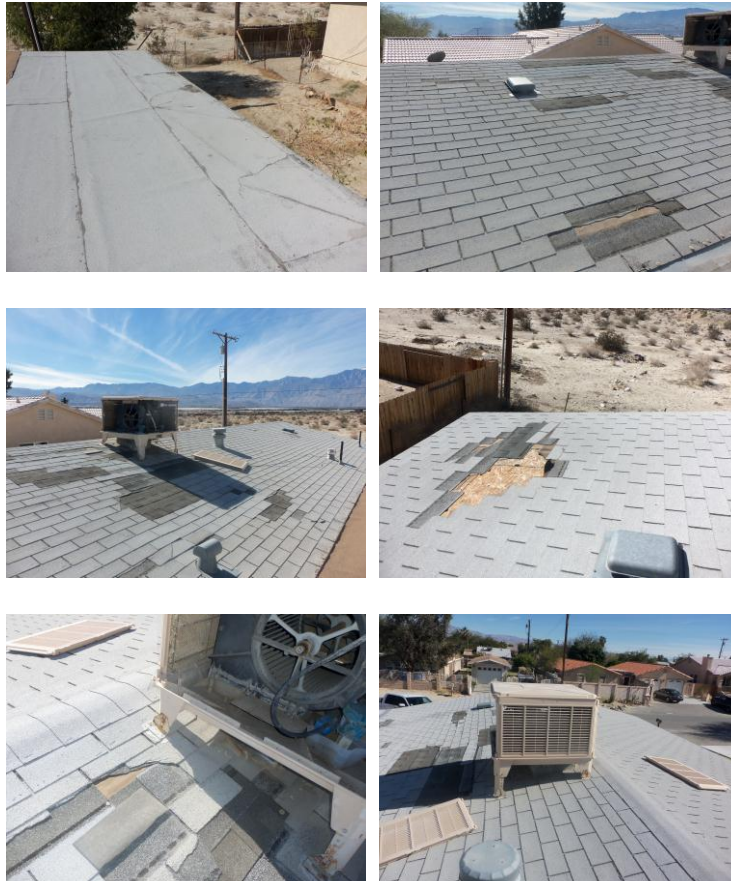
1205      Conditions      **Review.** Extensive wind damage at main structure with damaged rolled asphalt and exposed nails at carport.

We recommend review by a licensed roofer for repair or replacement, as necessary, prior to close.

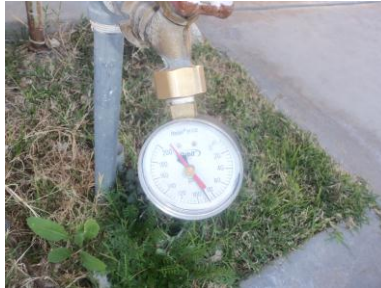
| Step # | Component | Comments |
|---|---|---|
| 1701 | Shut Off and Water Pressure | <b>Review.</b> Pressure was too high.<br>Pressure was 85 psi.<br>No pressure regulator provided.<br>We suggest review by a licensed plumbing contractor or the local water district for adjusting. |

| | | <ul style="list-style-type: none"><li>• Acceptable water pressure should be within the normal operating range of 40-80 psi</li></ul> |

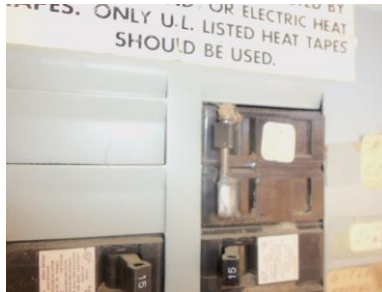
1. Unable to determine amperage value for A/C breaker.

- Maximum allowable is 30 amps. per manufacturers data label.
  -
2. Open knockout in meter panel should be sealed.

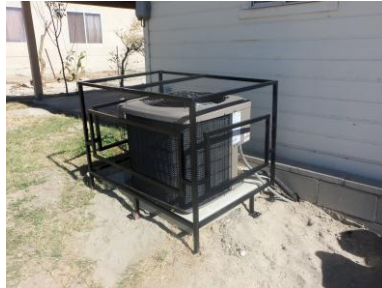
- 1910      Air Conditioning      Electric disconnect observed near this unit.
- Newer condenser observed contained in a locked security cage. Obtaining keys or replacing locks is advised.

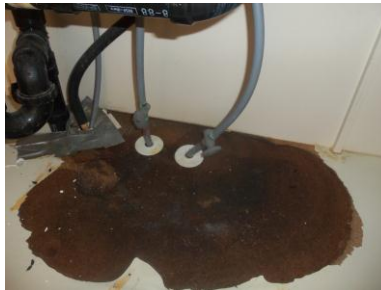
| Step # | Component | Comments |
|---|---|---|
| 2307 | Cabinets | <b>Review.</b> Under sink deck is damaged. |

See faucet.

| 2310 | Faucets | <b>Review.</b> Faucet leaks excessively. |

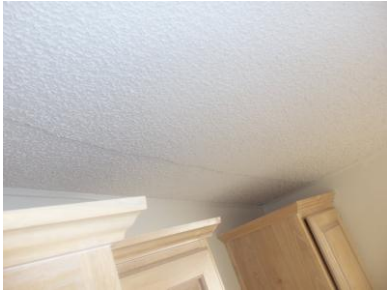
| Step # | Component | Comments |
|---|---|---|
| 2503 | Ceiling | <b>Review.</b> Cracked and offset.<br><br>Drywall. |

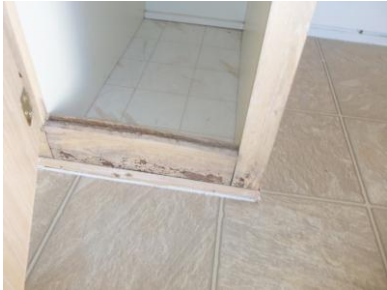
| Step # | Component | Comments |
|---|---|---|
| 2506 | Cabinet | <b>Review.</b> Water damaged.<br> |

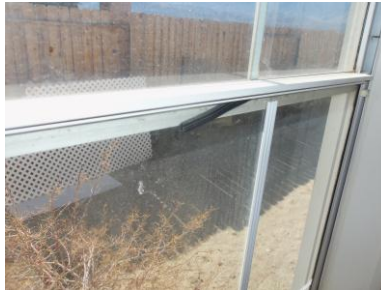
| Step # | Component | Comments |
|---|---|---|
| 2605 | Windows | <b>Review.</b> Frame is loose at master bedroom single hung windows. Gasket/seal is damaged. We suggest repairs to ensure proper operation and to prevent pinched fingers. |
