Doc #: Sample Inspection

Dwelling Address: 1234 Sample Street  
Memphis, Tn. 38127

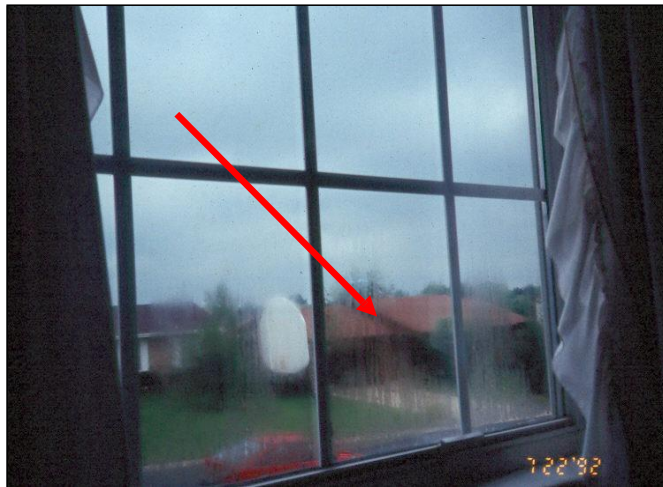
| Step # | Component | Comment |
|---|---|---|
| 1105. | Window &<br>Frames | <b>Review: Fog and condensation was noted in the double glazed insulated window panes at front left. This indicates a broken seal which will reduce visibility and the insulating capability of this window. To restore visibility and regain the insulating capability, replacement of this window pane is required.</b> |

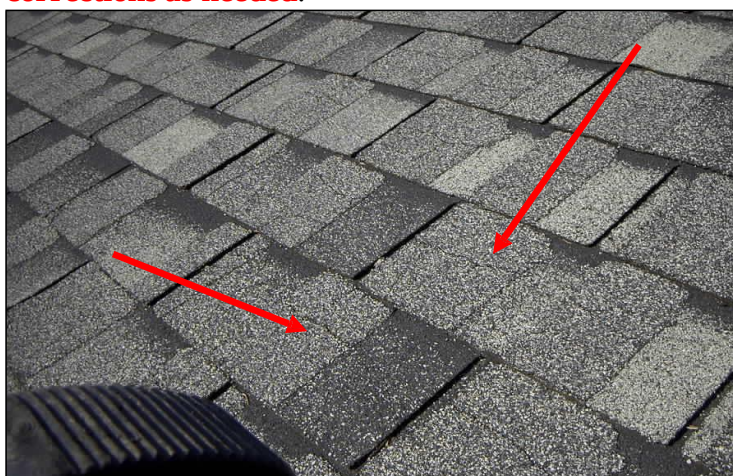
| Step # | Component | Comment |
|---|---|---|
| 1207. | Conditions | <b>Review. Roof shows signs of wear. Damaged, deteriorated roofing materials were observed; recommend review by a licensed roofing contractor for corrections as needed.</b> |

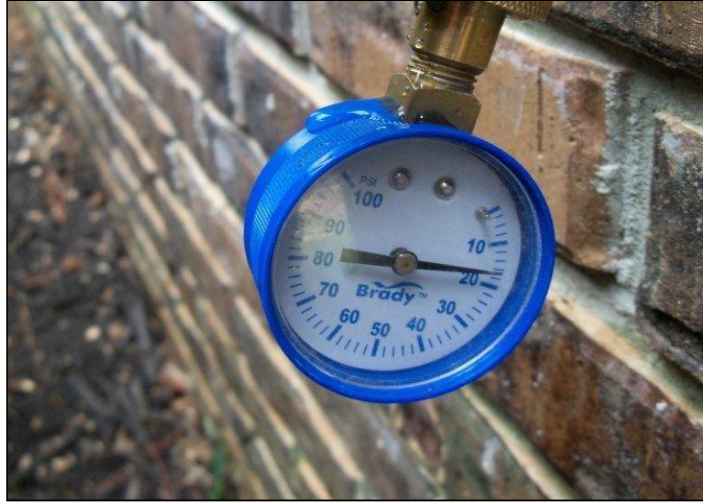
**Low water flow/pressure was observed at exterior right  
side faucet. Recommend review by a licensed plumber  
for repair or replacement, as necessary.**

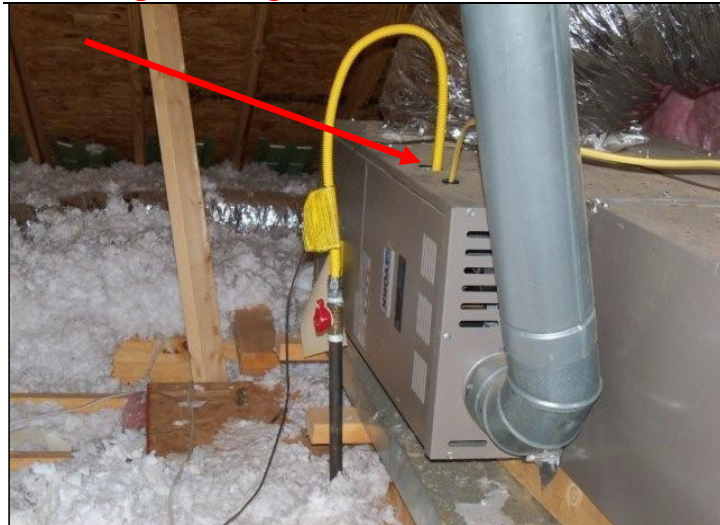
**The flexible gas connection for the furnace passes through the furnace enclosure wall. The connector could vibrate or become pressed against the sharp sheet metal side of the enclosure. We recommend that a licensed HVAC contractor use iron pipe inside the enclosure to help prevent possible damage to the gas line which might allow gas to leak.**

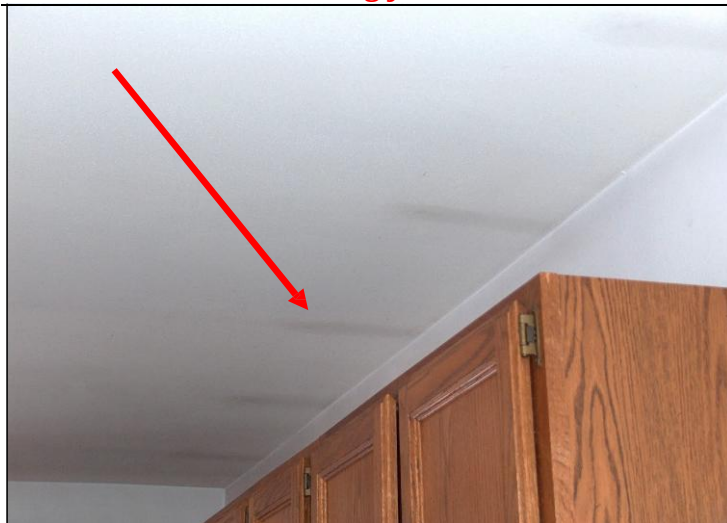
| Step # | Component | Comment |
|---|---|---|
| 2683. | Ceilings | <b>Review. Drywall. Shadowing observed on ceiling. Multiple candles were noted in the master bedroom. Usually shadowing is caused by the shoot from candles collecting on the colder service of the ceiling between insulation where the ceiling joists are located.</b> |

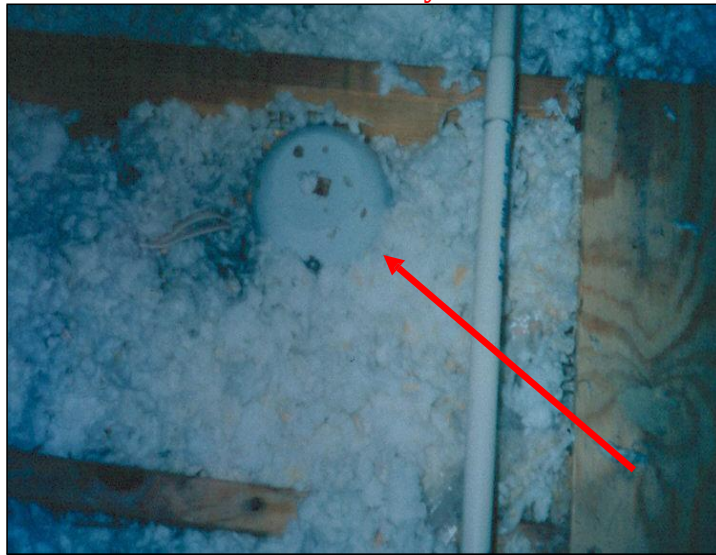
| 2708. | Electrical | <b>Review. Recessed lighting present in the attic may be a safety concern if insulation is too close or on top of these lights and/or if the lights are improperly installed. Please refer to the manufacturer's recommendations for each light for proper installation instructions or have these lights reviewed by a licensed electrician for proper and safe installation to ensure safety.</b> |

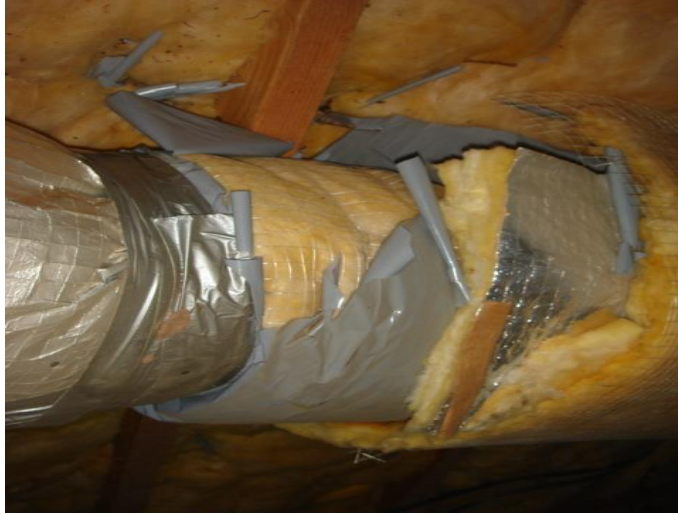
2709.      Distribution /  
              Ducting

**Review. Ductwork insulation is damage; corrections  
needed to improve efficiency.**
